### 3809 REPORT OF INSPECTION

Date: August 16, 2006 Time: about 12:15 pm Location: T.5S. R.24E. Sec 6 S2 of Lot 8

Serial no. of notice: UTU 66358 (Hiko Bell expired project area) Is the operation active? No

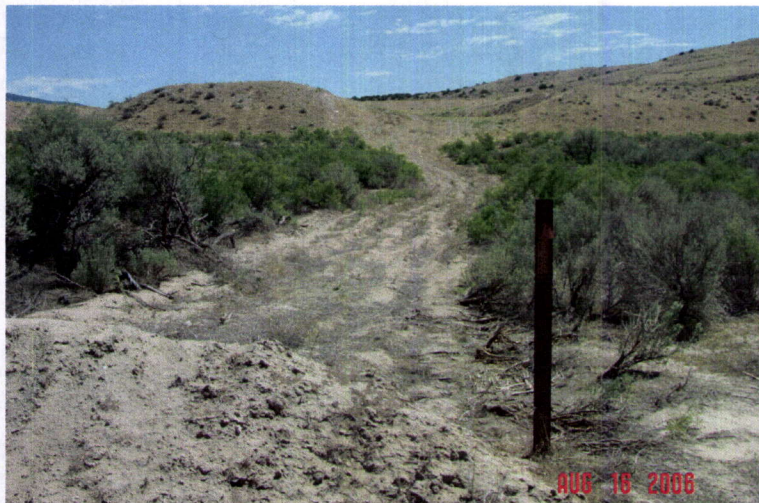
< image 1 view to east of west end of ripped road (constructed by earlier UTU66358 operator). A mound (to preclude vehicular traffic) and "reclaimed area, no vehicular traffic" sign is shown in foreground. Compare with image 1 from prior inspection.

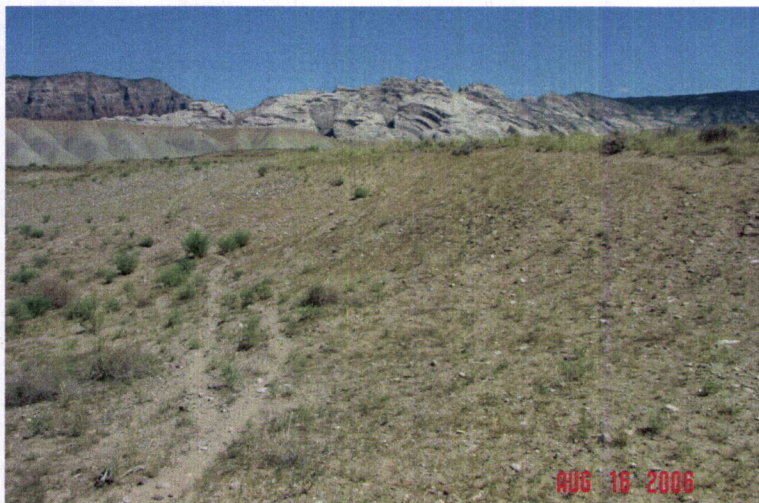
< image 2 view to north (from near the southeastern corner of the former project area). Compared with image 2 from the 2005 inspection there the grasses and shrubs are much larger and the OHV tracks noted

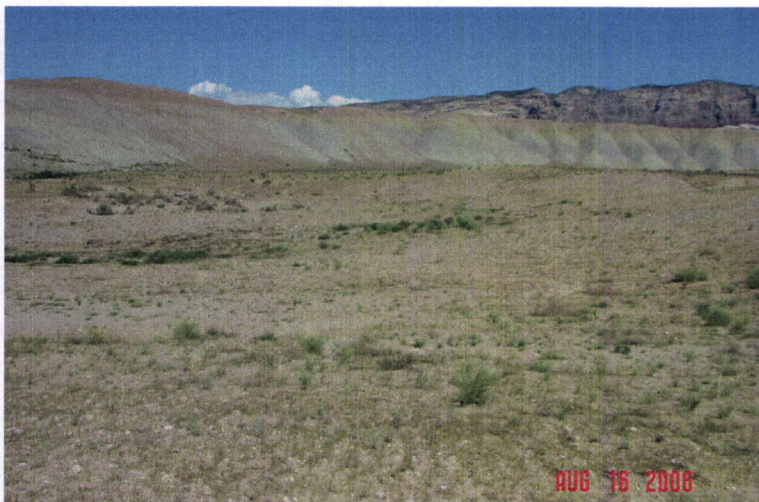
< image 3 view to north-northwest (pan to left of image 2). Reshaped and seeded area is stable and revegetation is well underway (compare with image 3 of prior inspection). OHV travel tracking from last inspection has been become weathered and masked by the emerging desirable vegetation.

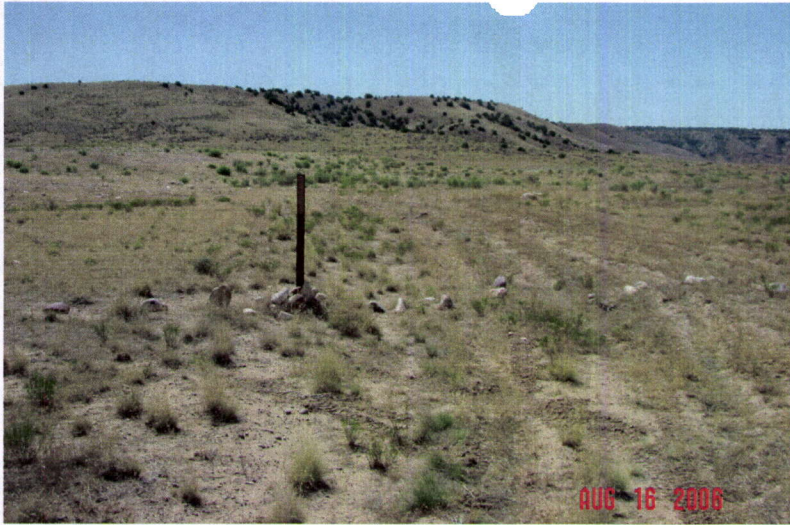
< image 4 view to south of the north end of the reclaimed access to UTU66358 that had tracked through expired project area UTU66354. During the 2005 inspection a vehicle had deeply rutted the ground to the right of the post in this image. The rutting (see image 4 of the 2005 inspection) was not apparent (had been weathered and overgrown with vegetation). Tracks from a smaller ATV had crossed into the expired UTU66354 project area (lower right to far-left).

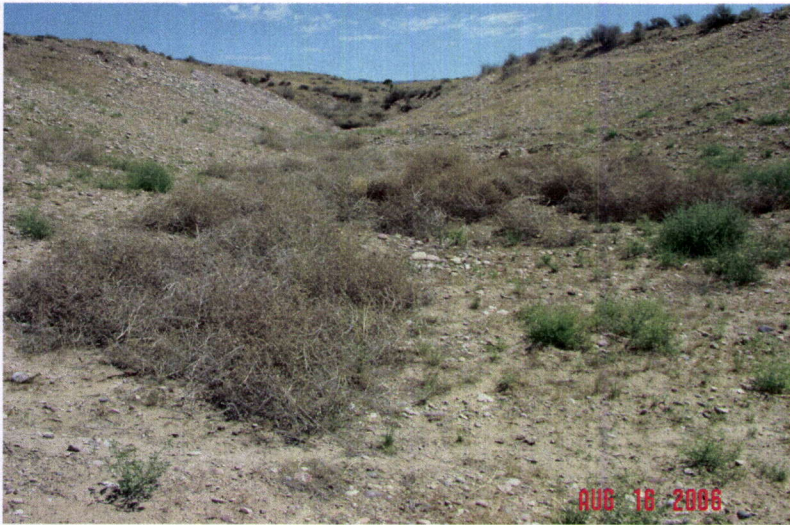
< image 5 view to east of [northern most] intermittent drainage (on east side of expired project area). Some Russian thistle has blown into this low point. Desirable vegetation is emerging which is providing sufficient cover and the area is stable. Compare with image 5 from the 2005 inspection.

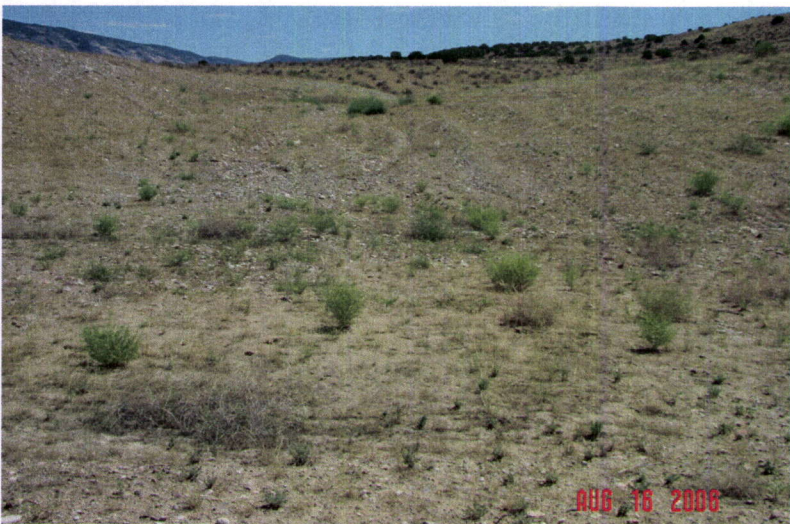
< image 6 view to east of southern intermittent drainage (on east side of reshaped expired project area). Desirable vegetation is emerging which is providing sufficient cover and the area is stable. Compare with image 6 from the 2005 inspection.

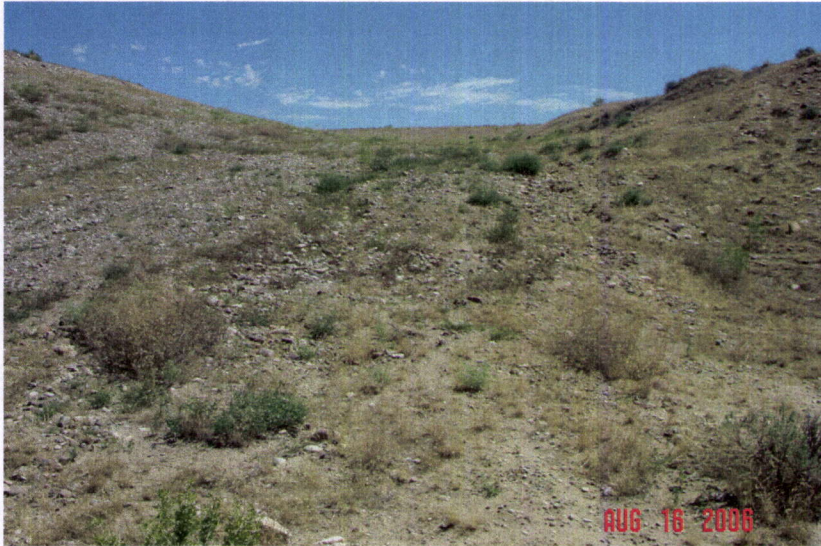
< image 7 view to east of [reshaped] intermittent drainage (in background of image 1). ). Desirable vegetation is emerging which is providing sufficient cover and the area is stable. Compare with image 7 from the 2005 inspection.
